## Orange Water and Sewer Authority

### Piney Mountain Subdivision Wastewater System

#### Asset Management Plan - October 2021

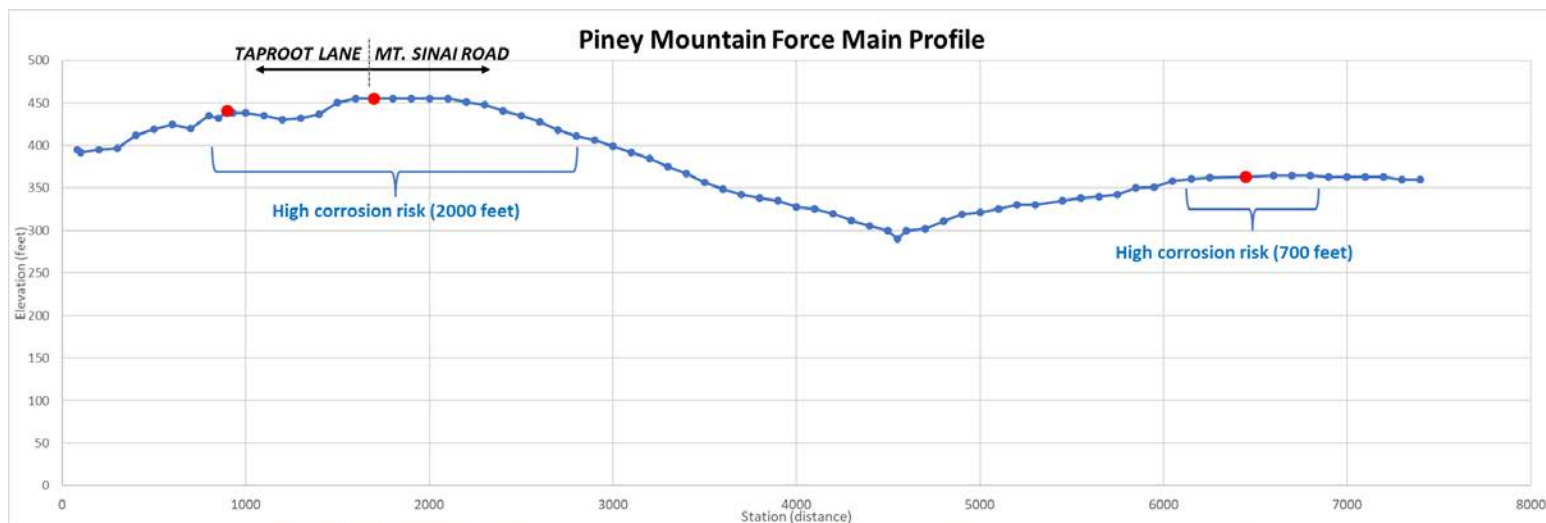
The approximately 7400-foot Piney Mountain force main runs from the pump station off of Taproot Drive, then along Mt. Sinai Road to the City of Durham manhole where the force main enters the City's gravity sewer system. The (elevation) profile of the force main is shown below and is based on the construction record drawings from the original 1995 installation. Three red dots in the profile show the locations of air release valves (ARVs), which are designed to be located at high spots in the line where air and sewer gases (particularly hydrogen sulfide) can accumulate. The presence of corrosive gases may lead to pipe wall deterioration and is one of the primary modes of failure for a ductile iron pipe, which is otherwise a relatively strong and long-lasting pipe material.

The force main profile figure shown above identifies the two sections near the ARVs where we currently expect pipe failure risk to be highest. Absent any inspection data to the contrary, we would expect a need to replace these sections on a more frequent recurrence than the remainder of the force main. Please note that this estimate of potential replacement need is based on the elevations shown by the construction record drawing; actual installation, if it differed in elevation or construction quality, could lead to other sections having greater failure risk.

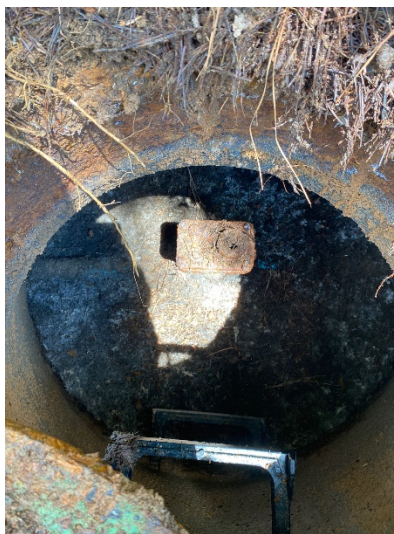
The ARVs are on a regular preventative maintenance schedule and currently are reaching the end of their useful life and need to be replaced. The ARVs are located near areas for potential air and sewer gas pockets around the high point locations along the force main. A photo of the ARV closest to the pump station (taken on 6/14/21) is shown below.
